BendPak Technical Service Bulletin

Four-Post Lift Column Deformation Field Repair

BendPak TSB 200-042026 Rev. A

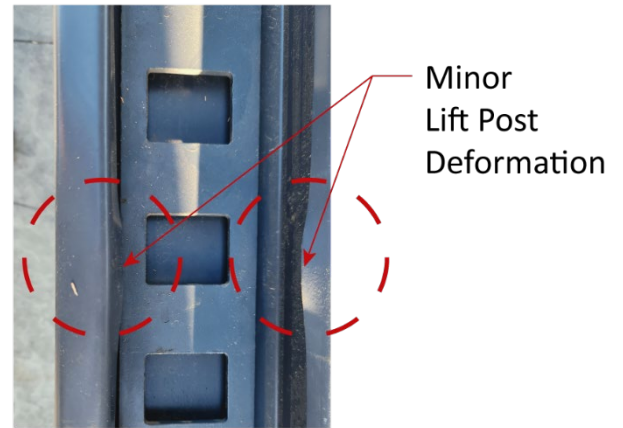
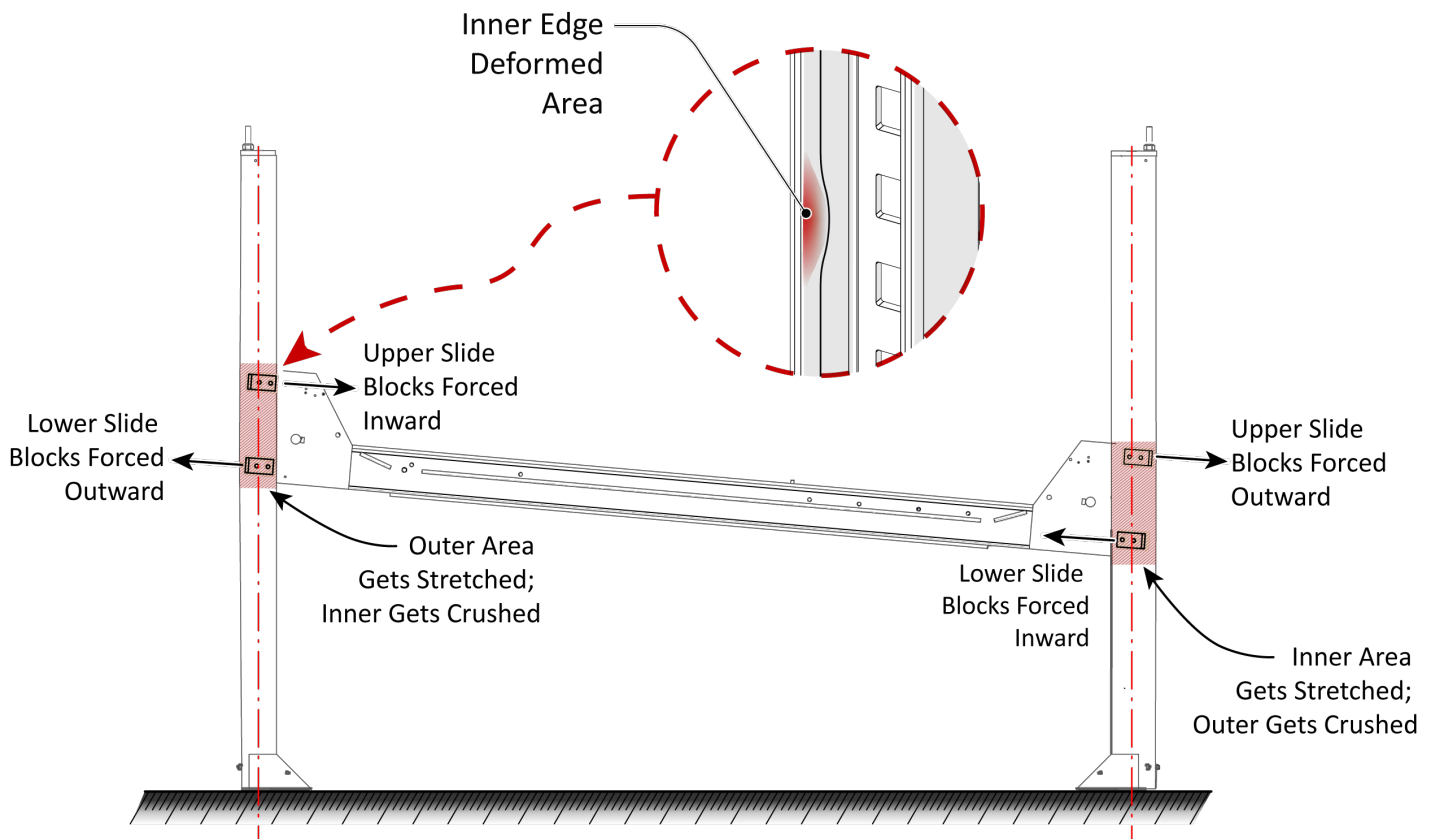
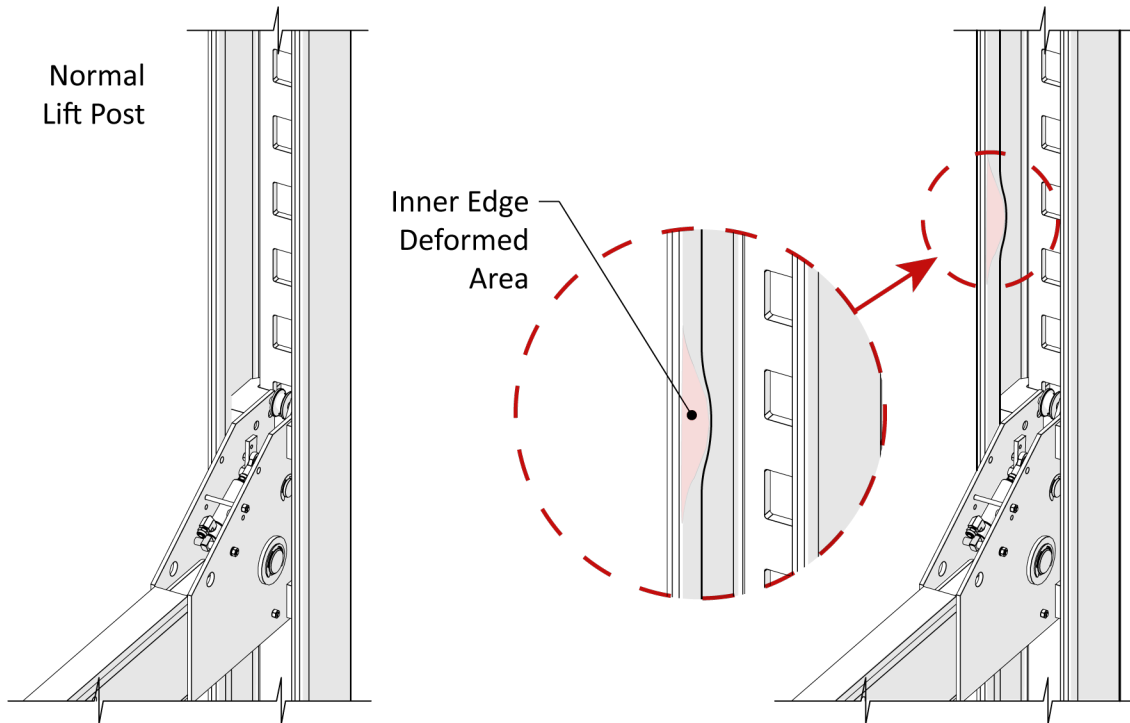
This Technical Service Bulletin describes the field repair of a minor column deformation along its inner and/or outer formed edge. Typically appearing at the level of the crosstube slide block, this deformation is caused by one corner of the lift's crosstube becoming restricted or locked while the other three corners descend normally. This causes the crosstube to depart its horizontal position in relation to the column. The crosstube slide block contacts and forces the column edge outward as three corners of the lift continue to descend. This is an operator-induced condition caused by improper (unlevel) lowering of the lift ramps under obstructed conditions, not a manufacturing defect.

1. Read this entire procedure before beginning.
2. Gather all required tools and supplies.
3. Ensure the Lift is safe in all respects before beginning work.
 - a) Both ramps are on the ground.
 - b) Lockout/Tagout the Lift power and verify zero energy:
 - o Turn the Lift OFF at the main disconnect/circuit breaker (or unplug if cord-connected).
 - o Apply an approved lock and tag (identify technician, date/time, and reason). Keep the key in your possession.
 - o Verify zero energy: attempt to operate the Lift controls (up/down). Confirm no movement occurs.
 - o Do not re-energize until specifically instructed to apply power.
4. Inspect all four columns along the entire crosstube travel path.
5. Identify and mark for repair all column inner or outer edges that appear to be rolled/flared.
6. Identify any scraping or impact marks from the crosstube contact.
